RE: REVISED SITE ASSESSMENT AND CLOSURE REPORT
Susan Davey Property
1279/1281 East Main Street
El Cajon, CA 92021
Unauthorized Release #H03126-001

SITE ASSESSMENT REPORT
REVISION NO. 1
SUSAN DAVEY PROPERTY
1279/1281 East Main Street
El Cajon, California
SECOR Project No. 08OT.04926.00
May 22, 2003

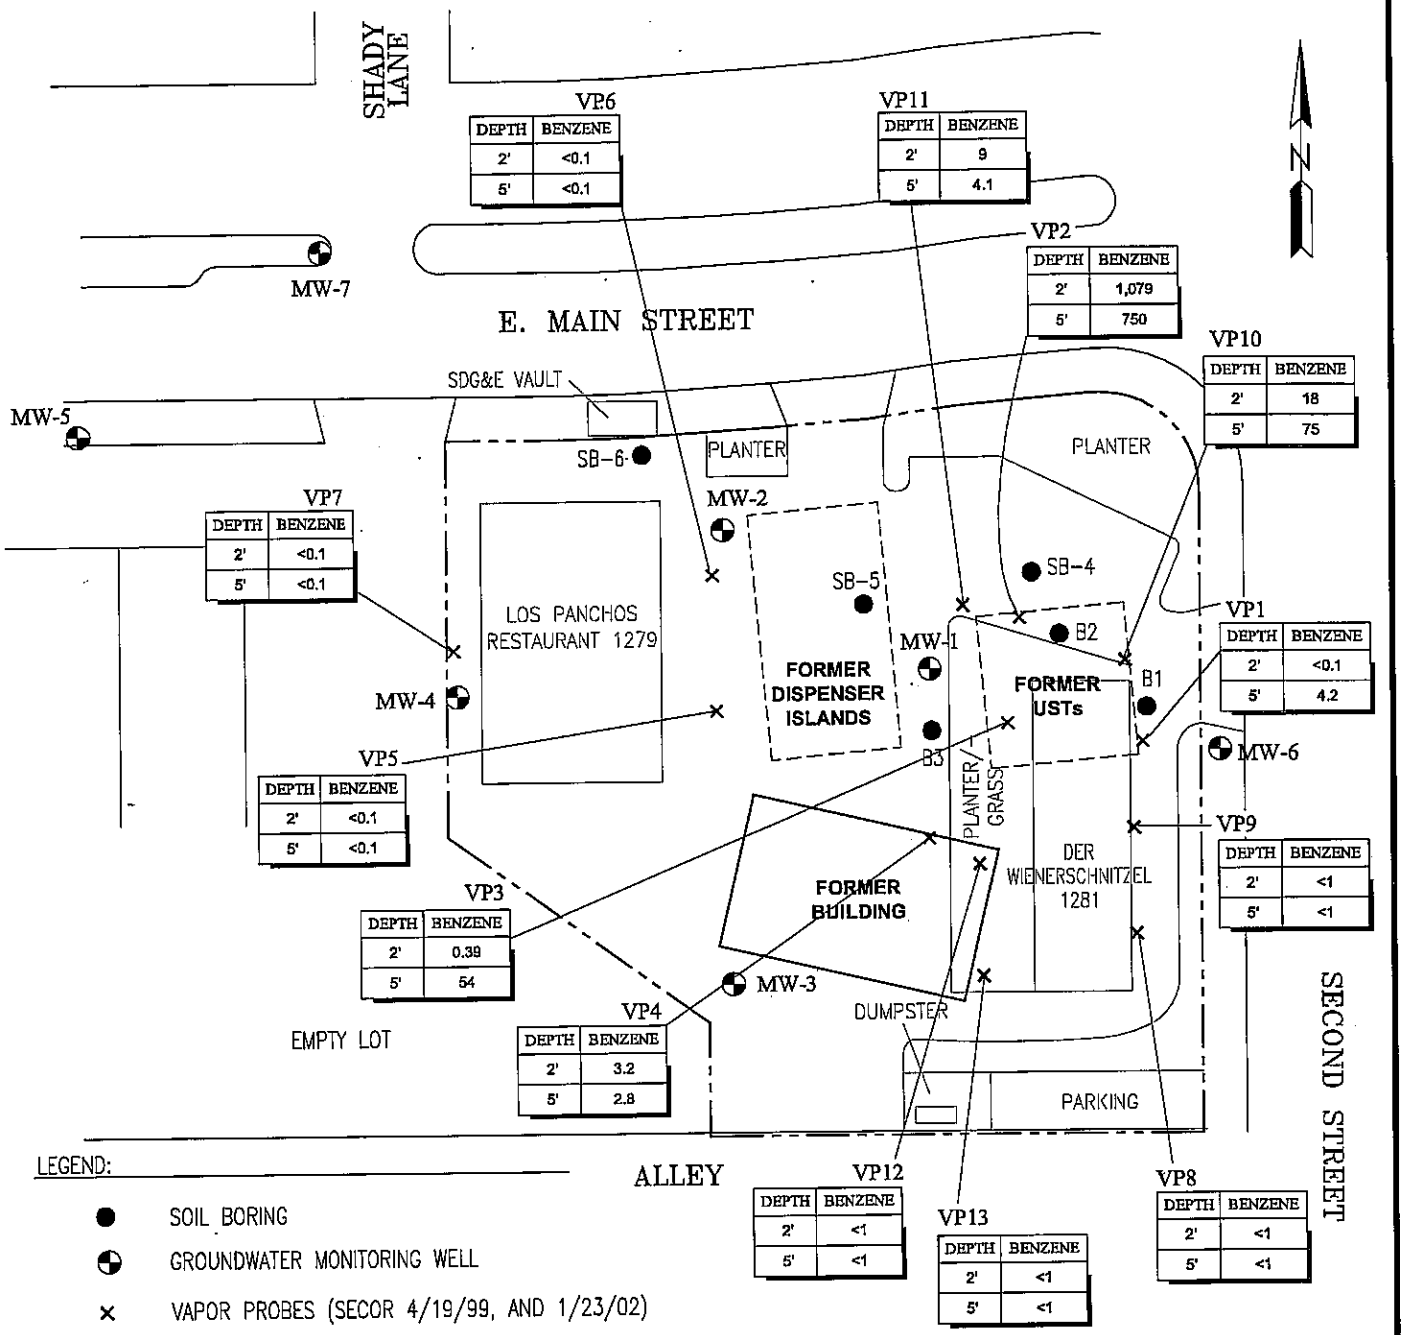
FIGURE: 3

Soil vapor sample analytical results, including locations and sample depths, are summarized in Table 4 and on Figure 3. A copy of the HP laboratory report is provided in Appendix A.

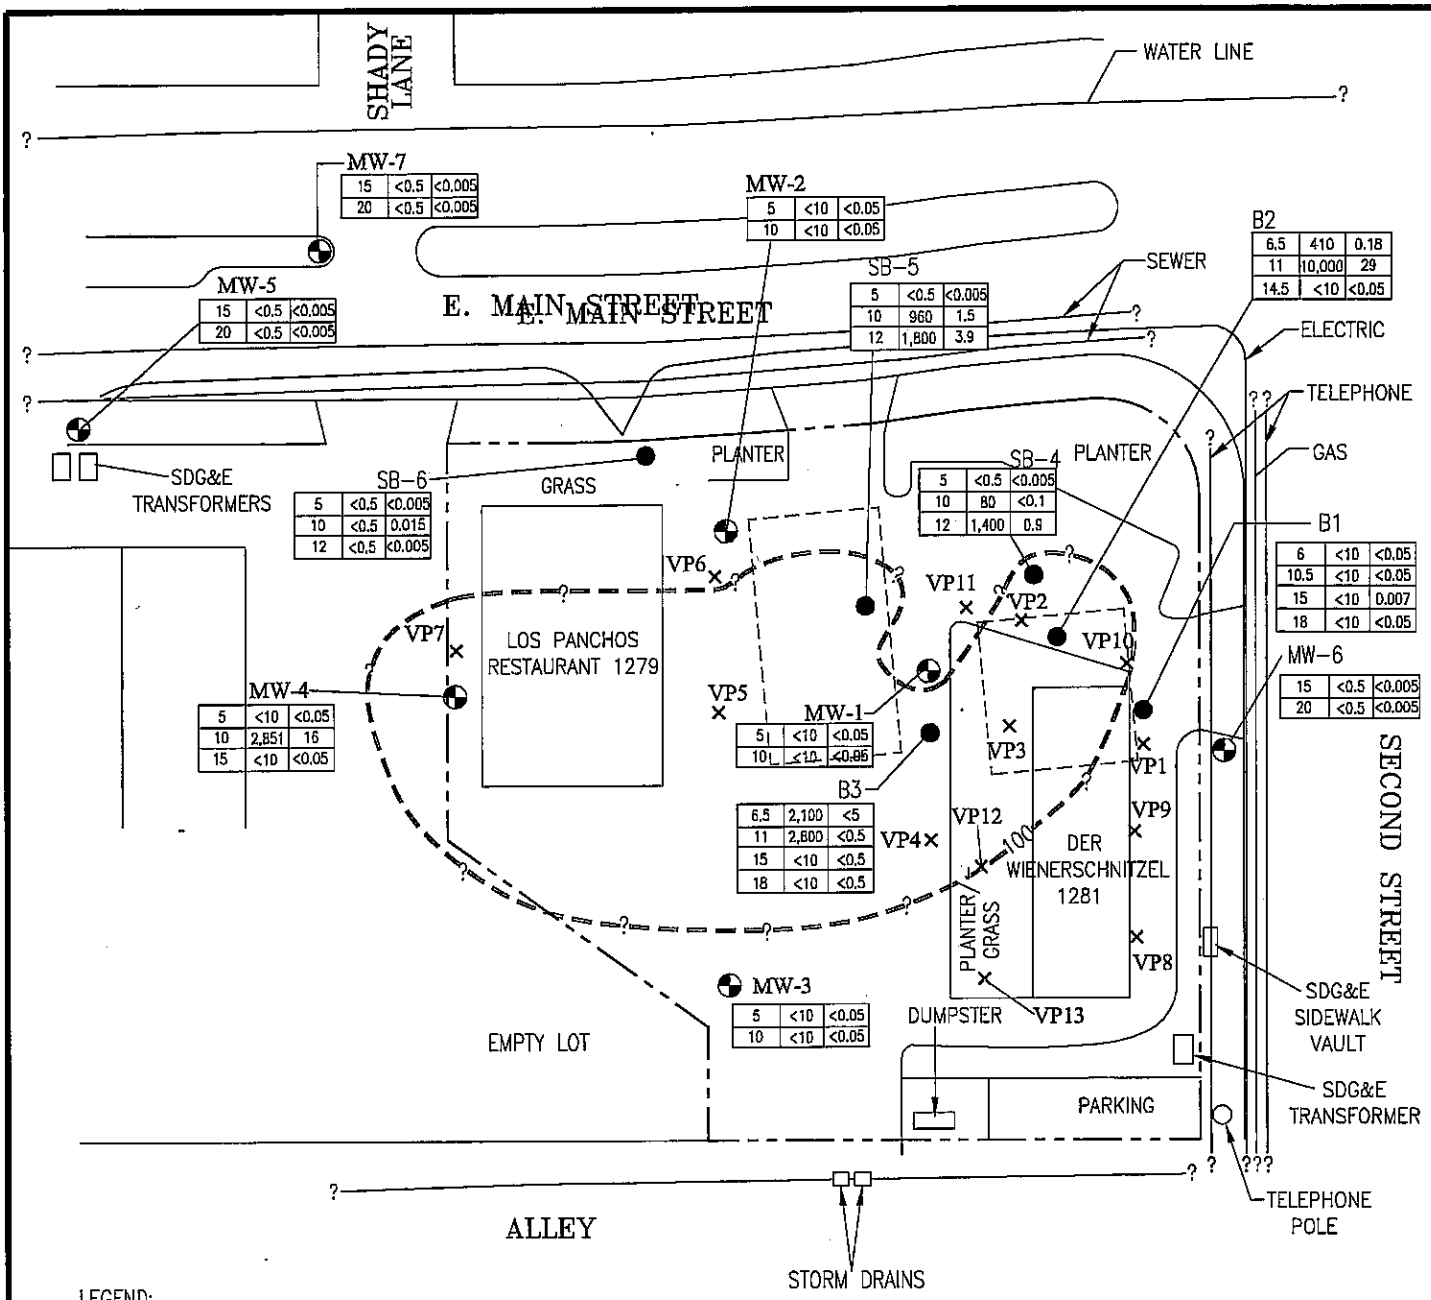
SECOR INTERNATIONAL INCORPORATED 2655 CAMINO DEL RIO N., SUITE 302 SAN DIEGO, CA. 92108 DAVEYHC.DWG 6/1/03	HYDROCARBON CONCENTRATIONS IN SOIL - DRILLING SUSAN DAVEY PROPERTY 1279 & 1281 E. MAIN STREET EL CAJON, CA.	PROJECT No.: 080T.04926.00 FIGURE: 5

Benzene concentrations were reported above the laboratory detection limits (ranging from <0.005 to 0.1 mg/kg) in four of the nine samples submitted for analysis. Detectable benzene concentrations ranged from 0.015 mg/kg in sample SB-6/10' to 3.9 mg/kg in sample SB-5/12'. The remaining five soil samples contained non-detectable benzene concentrations. Similarly, detectable concentrations of toluene, ethylbenzene and total xylenes were found in the same four samples. The maximum concentrations were 44 mg/kg toluene, 22 mg/kg ethylbenzene and 150 mg/kg total xylenes. All of these were found in the 12-foot sample from boring SB-5 (sample SB-5/12'). This boring was located in the north-central portion of the Susan Davey Property between the Los Panchos Restaurant and the Der Wienerschnitzel building. No MTBE concentrations above laboratory detection limits (<0.005 to 0.5 mg/kg) were reported in any of the soil samples submitted for analysis.

Elevated concentrations of TPHg and benzene were found in the 12-foot samples from soil borings SB-4 (located to the north of the Der Wienerschnitzel building) and SB-5 (located midway between the two restaurant buildings in the north central portion of the site). Soil samples from these two borings also contained detectable concentrations of toluene, ethylbenzene and total xylenes; the maximum concentrations of each constituent were found in the 12-foot sample from boring SB-5 (sample SB-5/12').

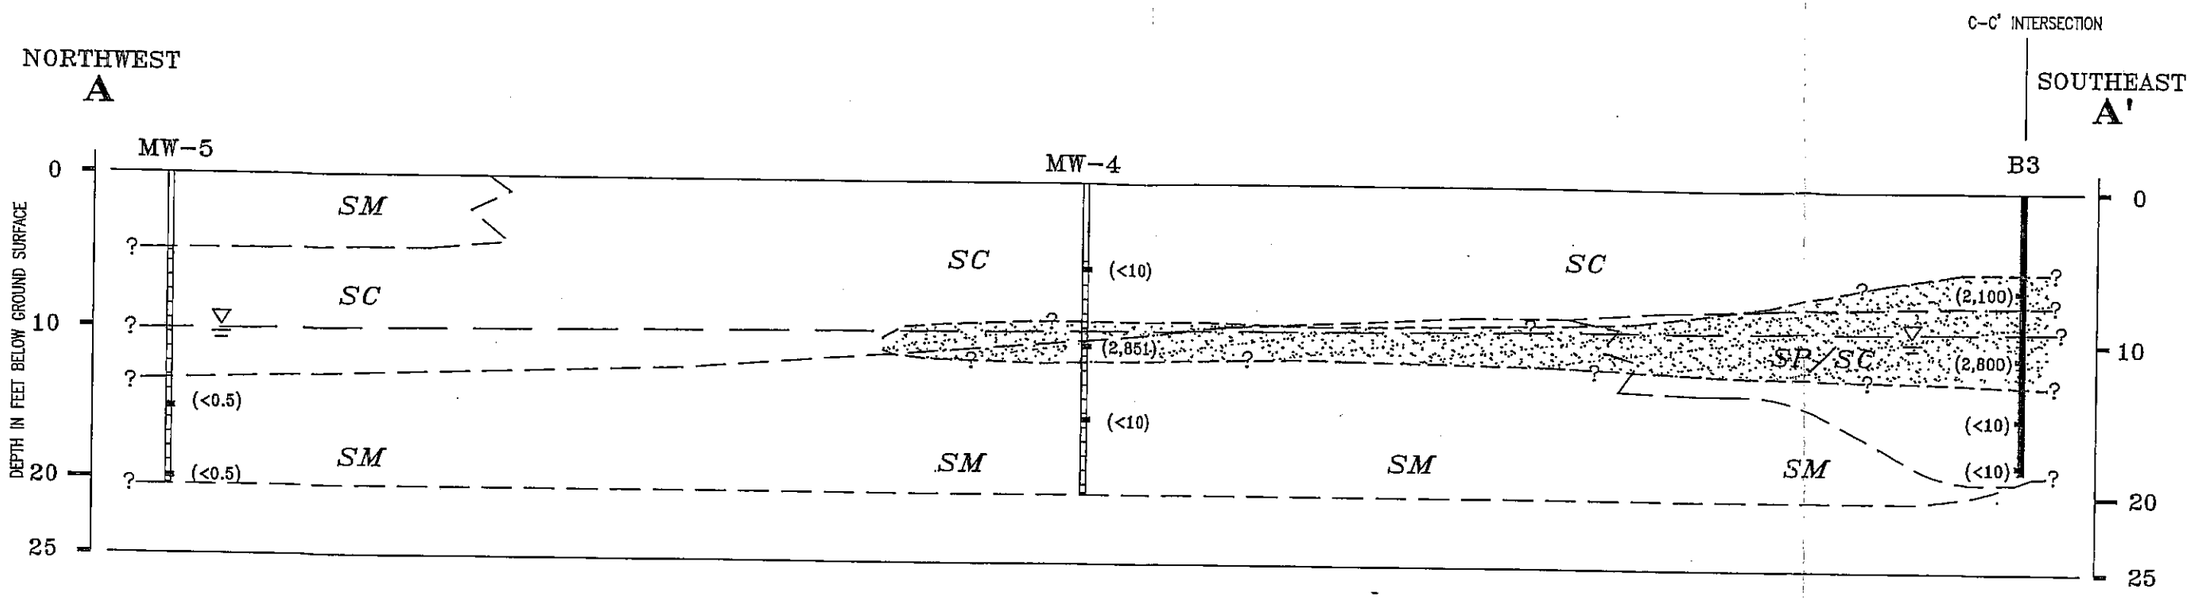
CAD FILE NO.: X-SECAA	PROJECT No.: 080T.04926.00
DATE: 4/26/02	FIGURE: 6

No groundwater was encountered during drilling to 12 feet bgs in various portions of the site. However, the reported static water level depths in existing monitoring wells ranged from 8.66 to 10.92 feet bgs. This suggests that groundwater locally is under semi-confined (instead of water table) conditions, since the apparent piezometric rise in the wells is at least 1.08 to 3.34 feet. SECOR calculated the groundwater flow direction to be to the northwest at a gradient of 0.009 ft/ft (Figure 9), using the surveyed well locations, surveyed wellhead elevations from Table 5, and the February 19, 2002 DTW measurements. Depictions of lithologic and hydrostratigraphic relationships in subsurface soils across the site are shown in Figure 6, Figure 7 and Figure 8.

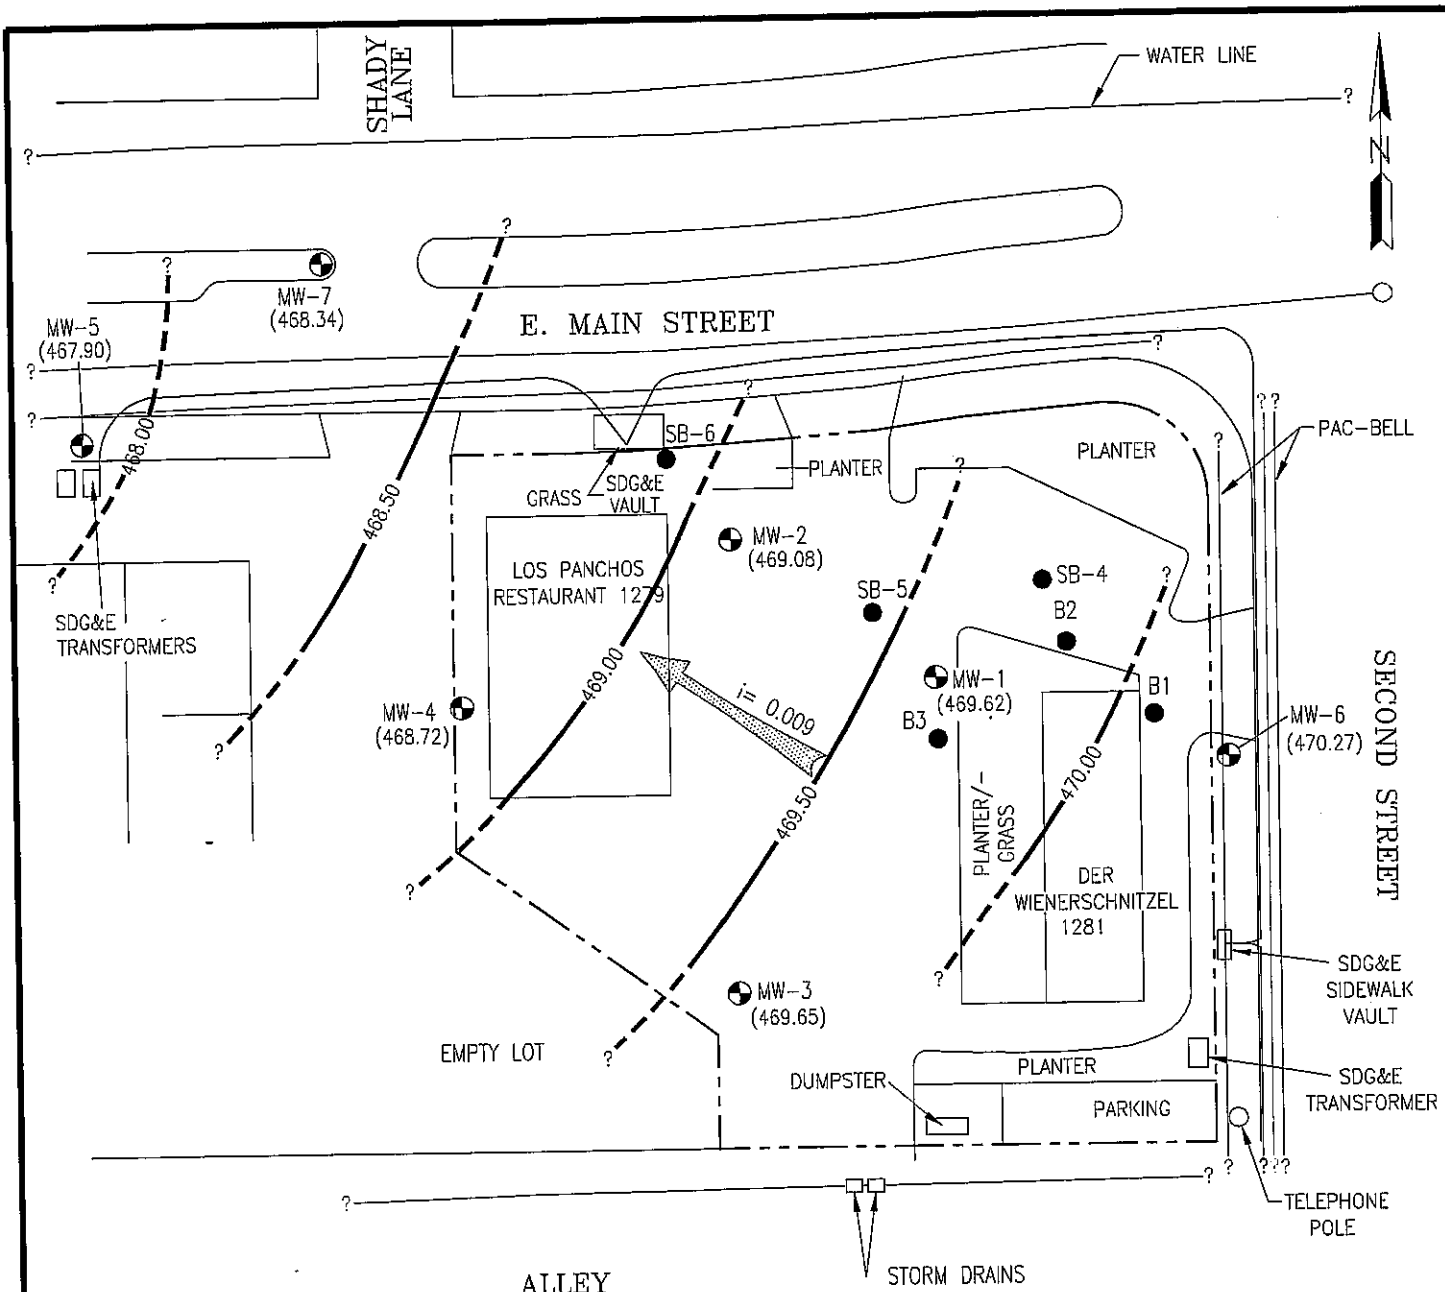
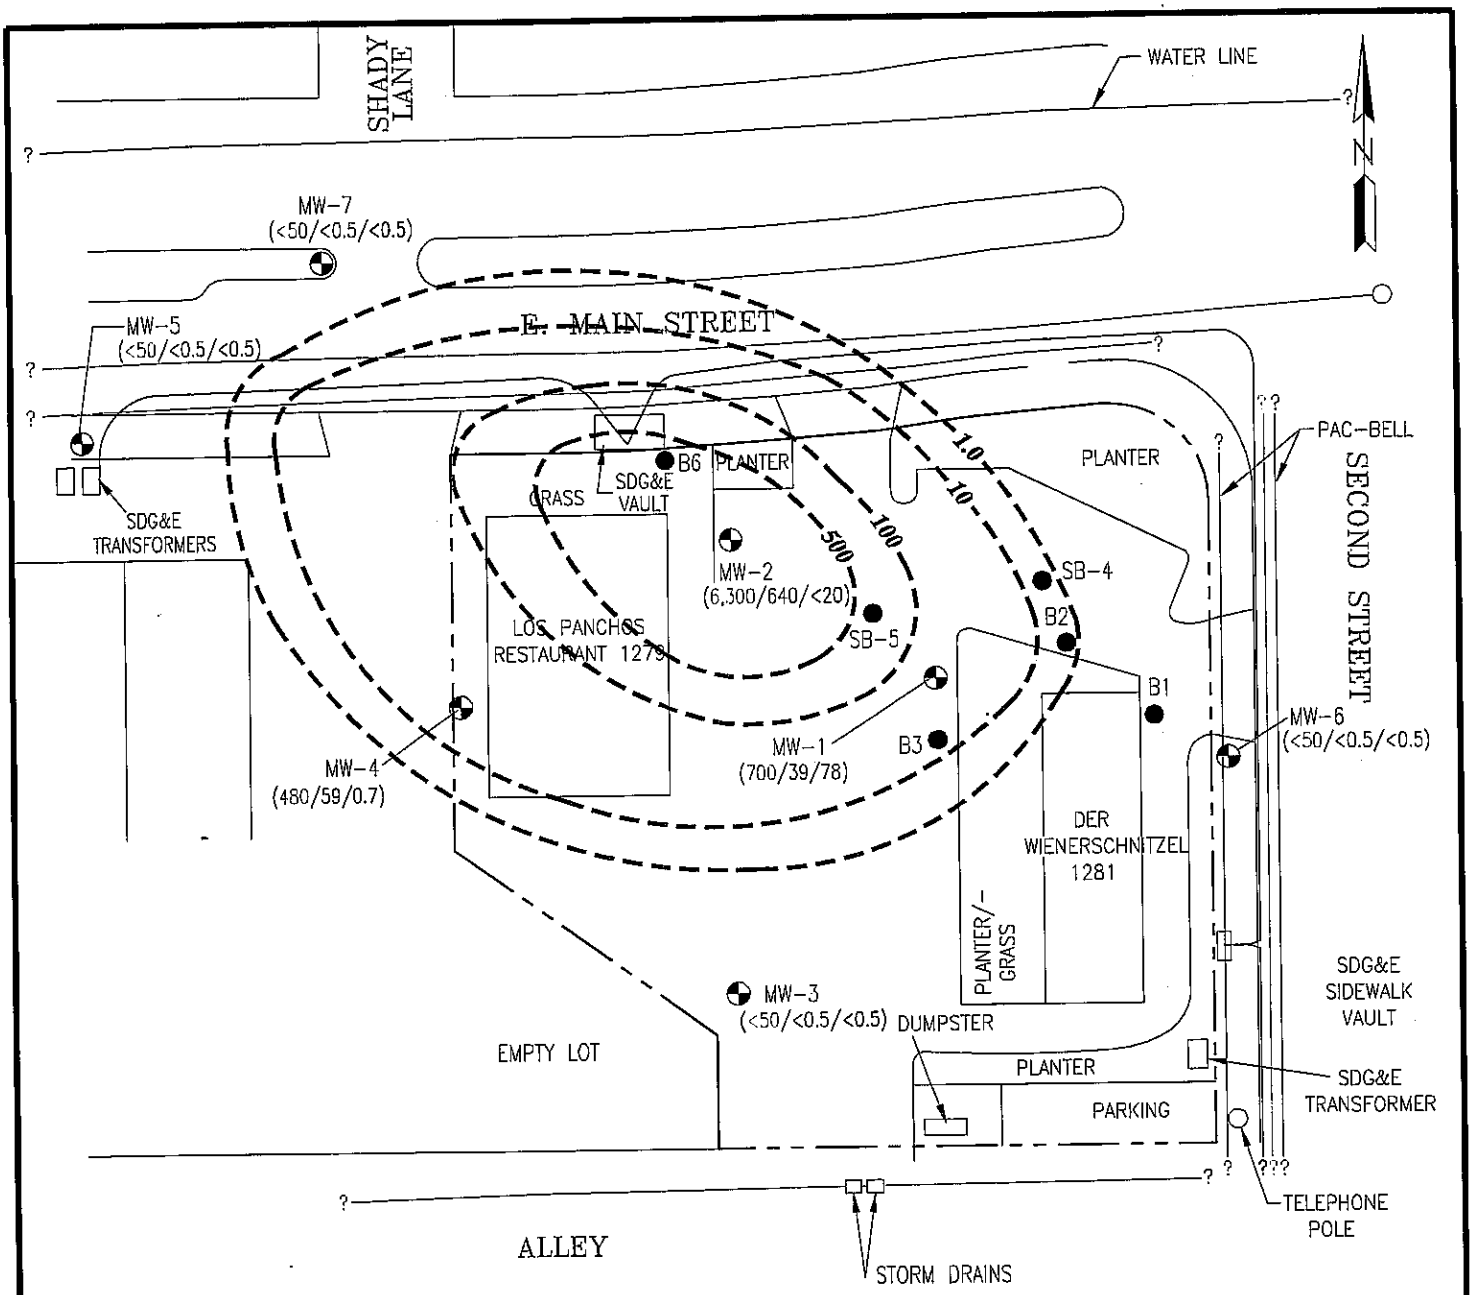
FIGURE: 9

Groundwater in the shallow aquifer beneath the site has been impacted by motor fuel hydrocarbons, including TPHg, BTEX constituents, MTBE, TBA and DIPE. The horizontal limit of dissolved hydrocarbon impact to groundwater at the site (in all directions) is defined by perimeter wells MW-3, MW-5, MW-6 and MW-7. Samples collected from these wells have not contained dissolved TPHg, benzene or MTBE concentrations above laboratory detection limits. Hydrocarbon-impacted groundwater appears to be limited to the vicinity of wells MW-1 (located near the Der Wienerschnitzel building), MW-2 (located between the two restaurant buildings, but closer to Los Panchos Restaurant) and MW-4 (located near the western wall of the Los Panchos Restaurant), all of which are either located in the center of and/or immediately cross-gradient from the former UST excavation and dispenser islands (Figures 9 and 10).
